Experimental Determination of AH-64 Apache Tailshaft Hanger Bearing Vibration Characteristics with Seeded Faults

ARL-TR-4865

June 2009

**Brian Dykas, Timothy Krantz, Harry Decker, and David Lewicki
Vehicle Technology Directorate, ARL**

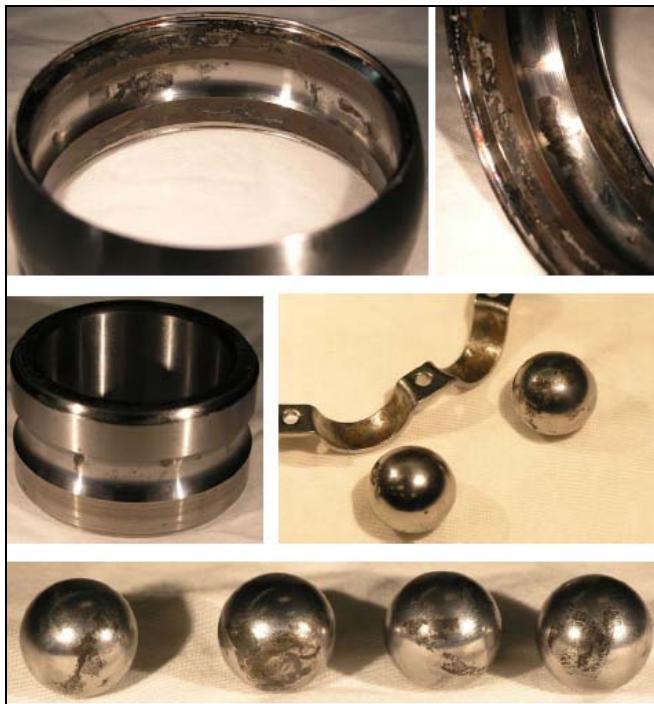
After the vibration signature tests were completed, one bearing prepared according to each method was disassembled and cleaned in an ultrasonic bath to be able to better inspect and quantify the severity of corrosion damage. The disassembly photographs of 019-ARL-RS are shown in figure 12, and corroborate the pretest visual inspection of the grease and the vibration data. Corrosion damage was found on both races, the cage, and the balls. The inspection of 018-ARL-SW did not show any corrosion damage to the bearing components, as was expected based on the pretest grease visual inspection and the vibration test data.

Figure 12. Photographs of corrosion damage to bearing 019-ARL-RS after post-test disassembly.

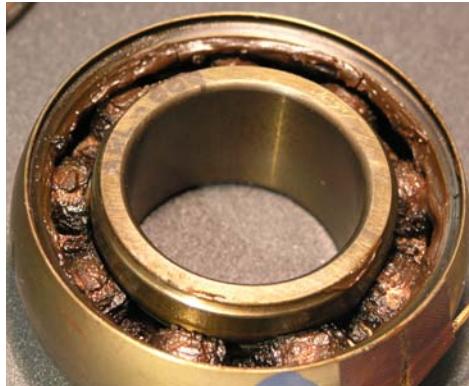
conducted. Figure 17 shows the grease appearance after 1600 hr of run time at light load and high temperature. The increased temperature acts to accelerate the life of the grease, decreasing the required test time. To date, the bearings have operated remarkably well given the severity of lubrication degradation.

Figure 17. Grease appearance after 1600 hr of elevated temperature (accelerated life) operation.
